A 3 Year HotVac Cure to a Serious Problem

She Traveller *Dev*, successfully completes a lengthy programme of treatment for a nasty case of osmosis

Dev is a She 9.5m Traveller built in the UK at South Hants Marine's yard at Chandlers Ford in 1974. This article covers the period 2011 to 2013, when she underwent thorough osmosis prevention treatment using the HotVac system.

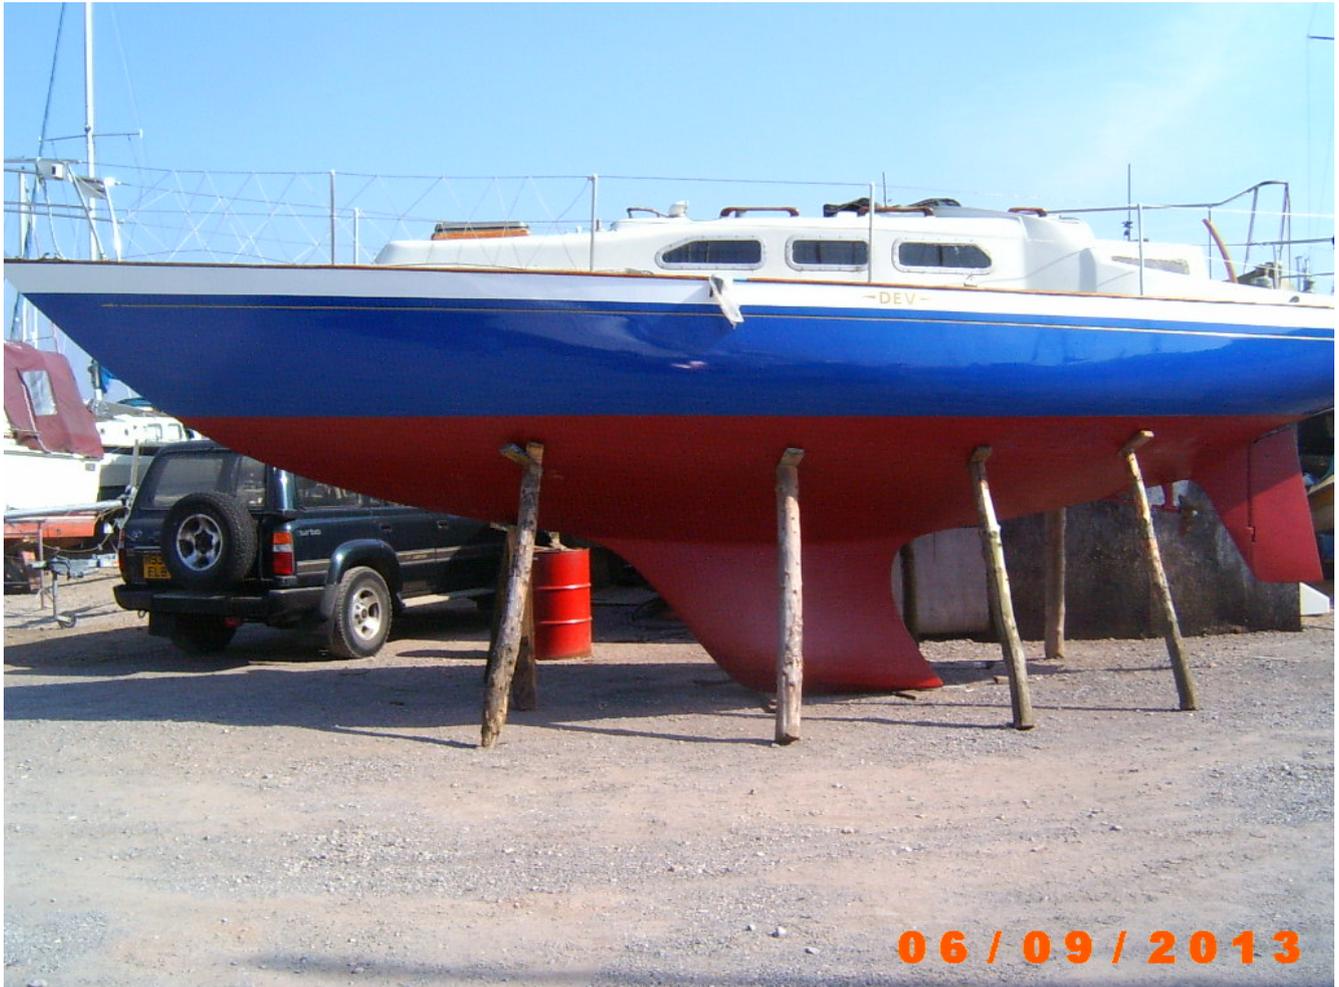
Dev after the work was completed: a sleek underbody

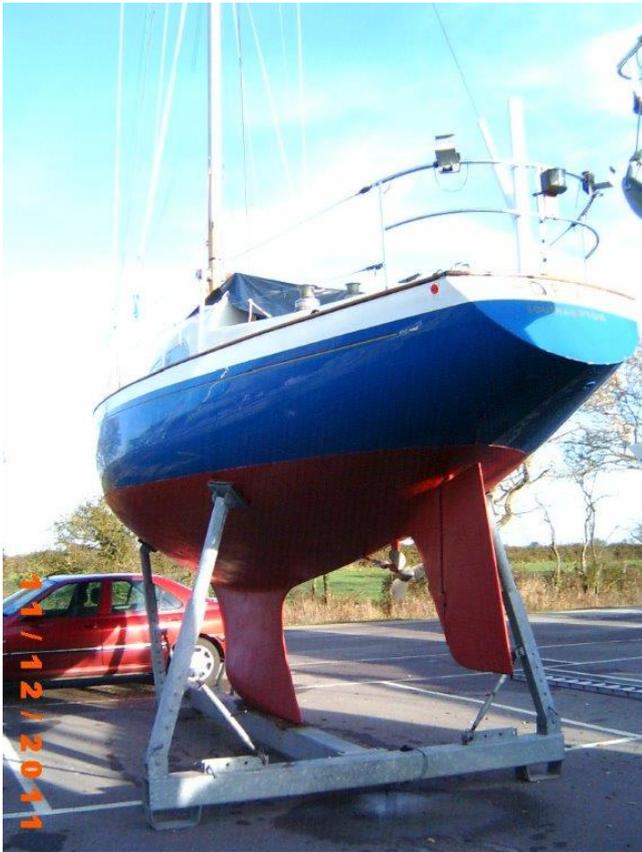
In the low November sun small deflections were seen on port and starboard topsides in line with the forward lower shrouds below the chainplates.

Deflection on the port side

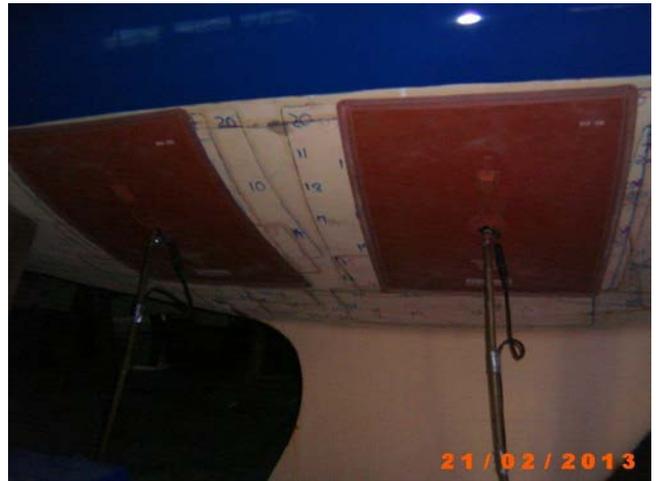
The hotpads in action

The photo shows progress of drying using the hotpads without peeling the gelcoat. Even at this early stage the dryness forward is down to 5% and 4%. Rust on the keel had developed after the earlier shot blasting whilst *Dev* was outside in the yard. The pipe attached to the hotpad is subject to vacuum and allows drainage of water and unwanted crystalline deposits; the electric cable is for the heating element. As the next photo shows readings varied within a small area.

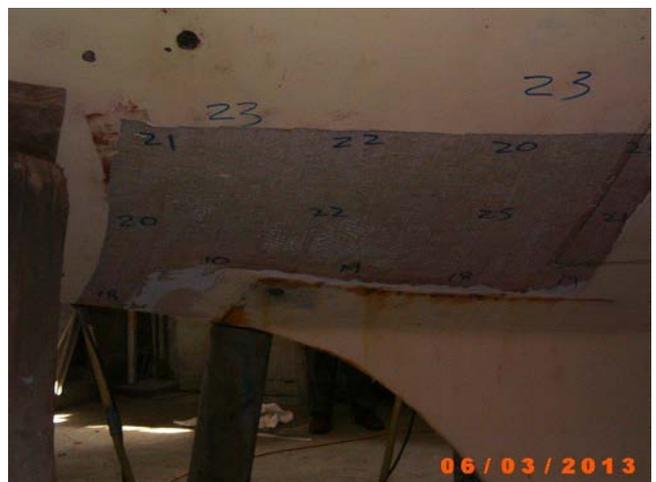
Variable readings and evidence of delamination

We had agreed to peel areas where de-lamination was suspected, part of which is shown in the photo.

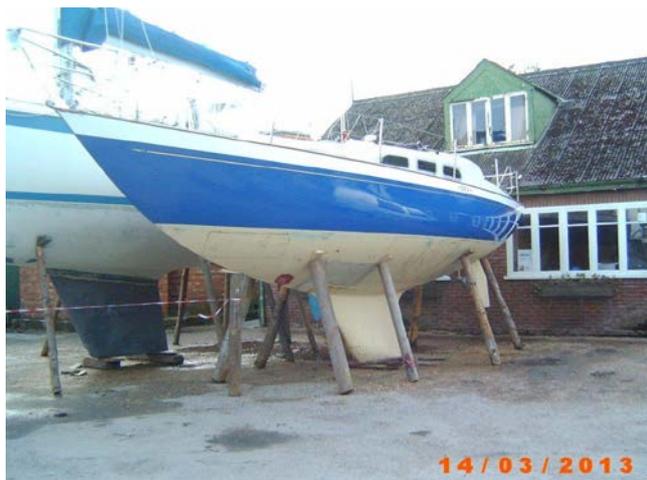
The new topsides

This shows the repainted topsides. Drying stopped temporarily as *Dev* was moved from the paint shed into the yard where she collected a coating of snow and some water into the after locker and bilges. Before final work started it was important to check there was no water in any internal areas: lockers, bilges, the heads, holding tanks and the engine exhaust system, wherever they are close to the outer surface.

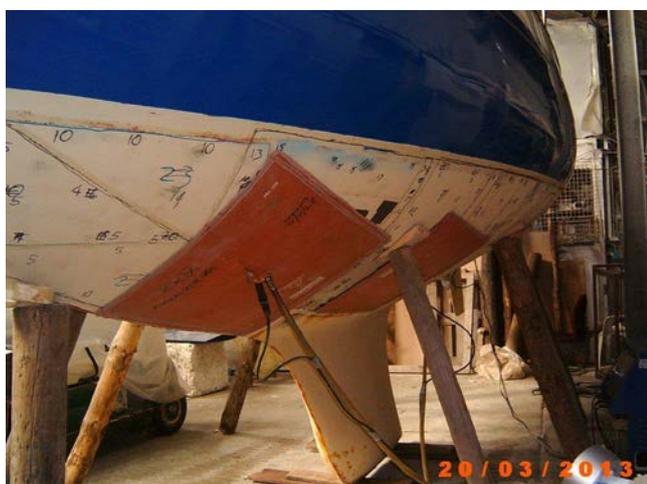
Continuing progress

This photo shows progress back in the shed. At this time it was decided that a full peel was needed and a superior treatment that included the addition of one layer of 40 biaxial cloth using an epoxy resin, over the underwater area, excluding the keel and rudder. Peeling and grinding produced a lot of glass fibre and resin dust; boiler suit and breathing mask were needed for work on board.

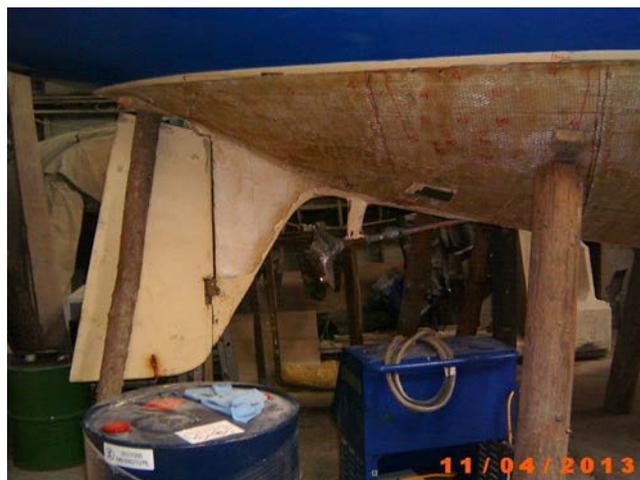
The next photo shows the after end of the peel and the holes to drain the rudder. Areas that had not responded adequately to the hotpad needed an infrared

After the peel

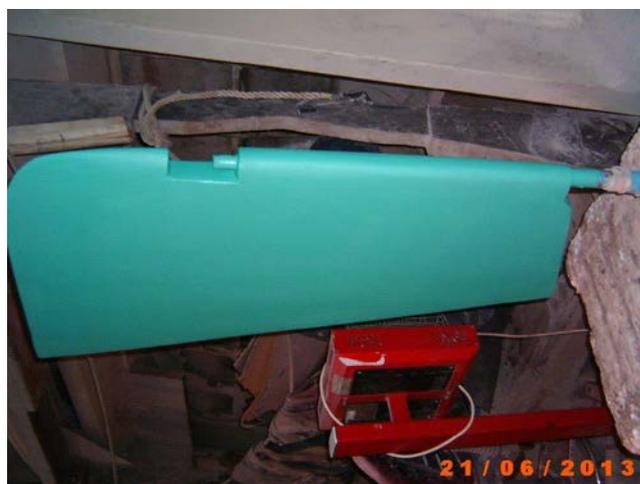
heater. Another photo shows the rudder after coating with Gelshield 200.

The repainted rudder
