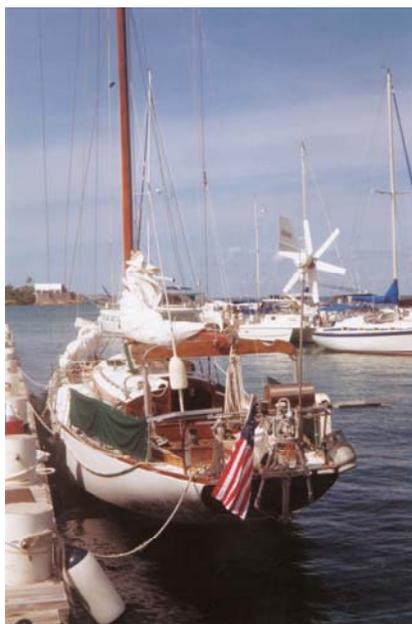
Vixen relaunched

VIXEN was launched with little fanfare but very excellent champagne in November of 1997. A splash for the boat and the rest applied internally. There were no girlfriends present. The Virgin Island ‘yachting guides’ were dismayed as they could no longer give directions into the Salt River Marina which read “turn into the marina when the derelict boat on the beach bears 220 magnetic.” We have sailed more miles since than in all the preceding years. *VIXEN* sails as well as ever and is slightly better on a starboard tack.
