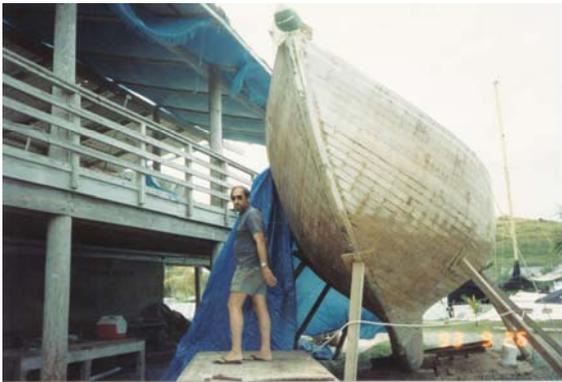
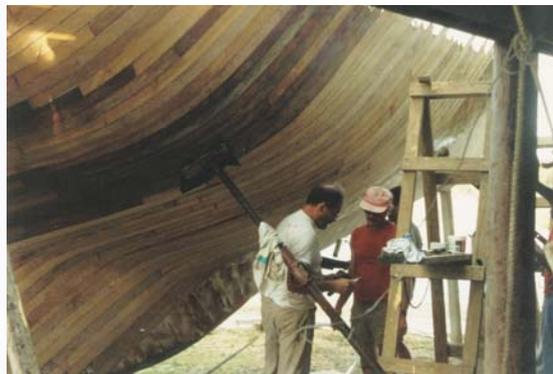
I hauled *VIXEN* on December 19, 1992. It was a relief just not to worry about her going down again. After a month or so of drying out, I began grinding the hull down to bare mahogany. This took several long weekends. Following the grinding, I removed all of the caulking. I started stripping the putty and cotton using the traditional sharpened hoof pick and bent screwdrivers method. This was time consuming and tedious. At this point, I still thought that I was in for about six months of work. In order to accelerate the process, I tried several things but finally settled on using a small high-speed 4" circular electric saw. The blade of the saw was set fairly wide and was corundum tipped. This saw literally ripped the cotton and putty out. This still took a while to complete. I soon found out why she had leaked all these years. Some of the

seams showed more than 3/8ths to 1/2 inches of daylight. *VIXEN* had been in the water continuously for nearly twenty years and the hull was thoroughly saturated. *VIXEN* had to completely dry out. (A process recommended for wooden boats and men in the tropics.) This drying took the best part of a year. Moisture meters became the bane of my existence. I learned to hate rain. The tropical sun was my only friend. I tried to maintain rain tarps over the boat but the trade winds made my efforts laughable. Did you ever try spinnaker flying on land?
